APPENDIX B: FIELD SITE ASSESSMENTS

4-Stream, 3165 BUFFALO RD, -77.117102, 39.488838

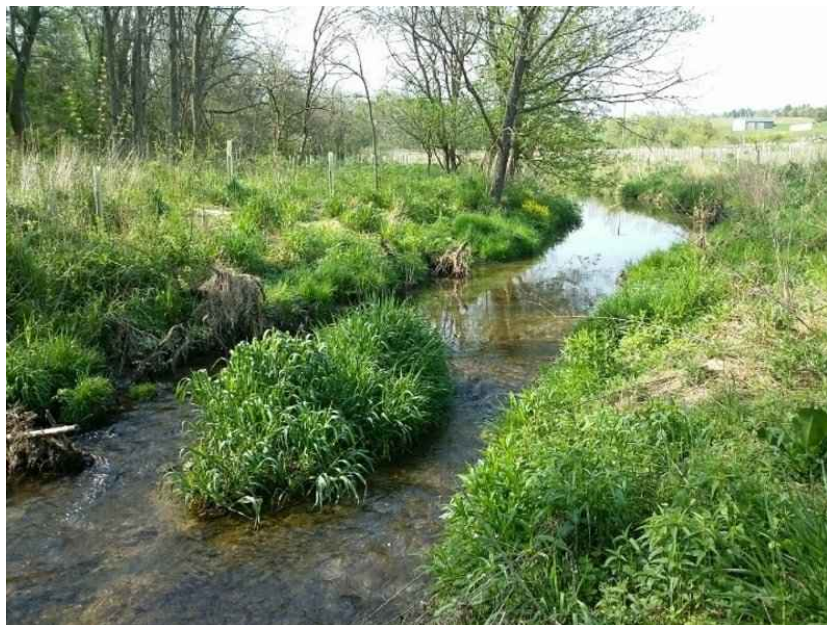
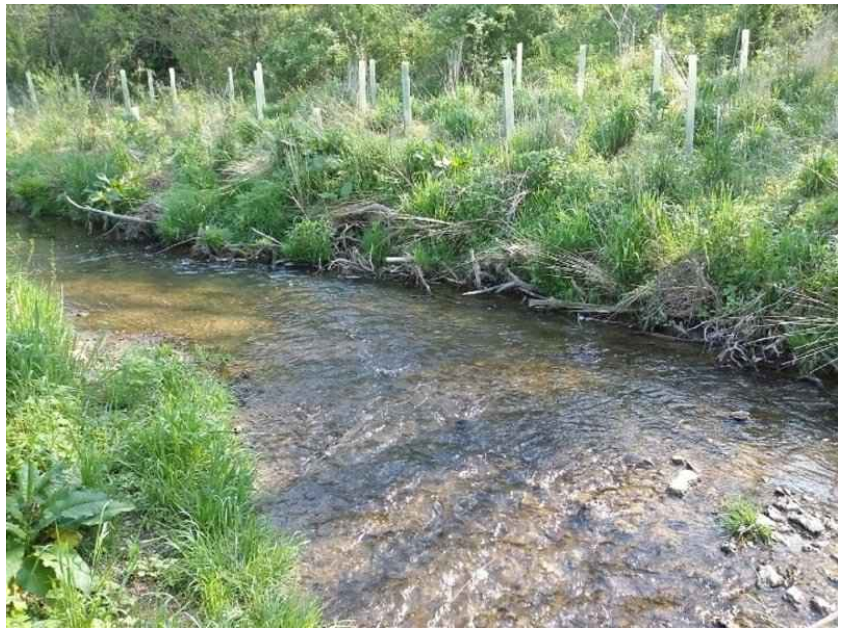
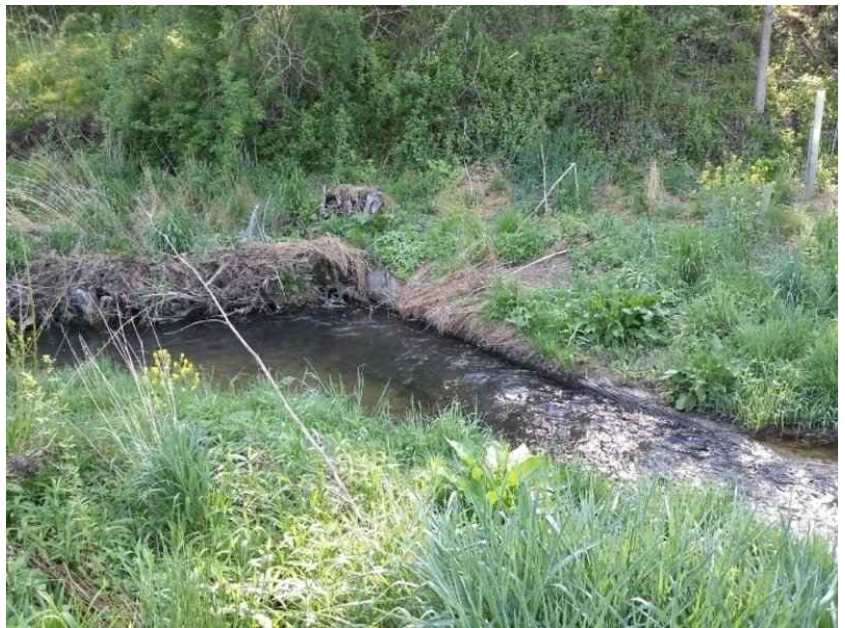
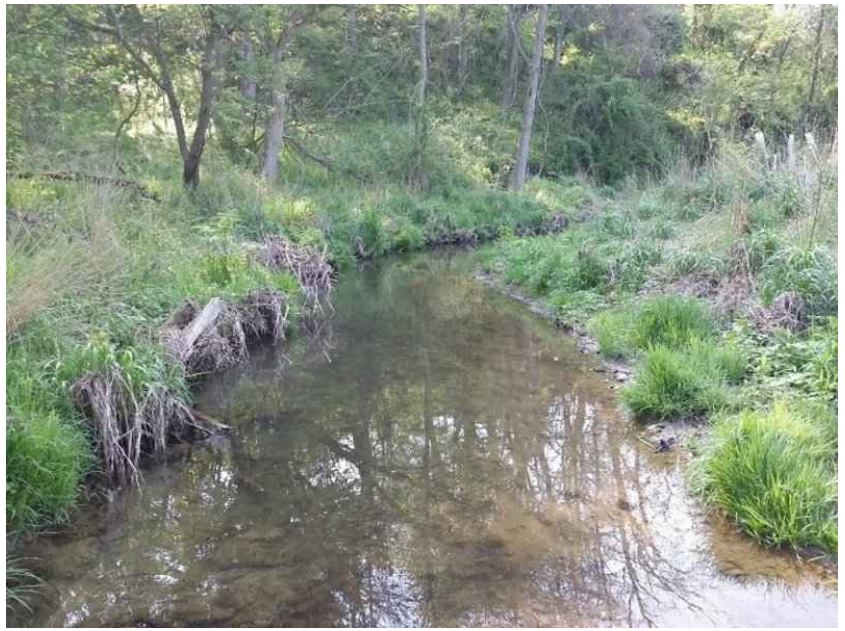
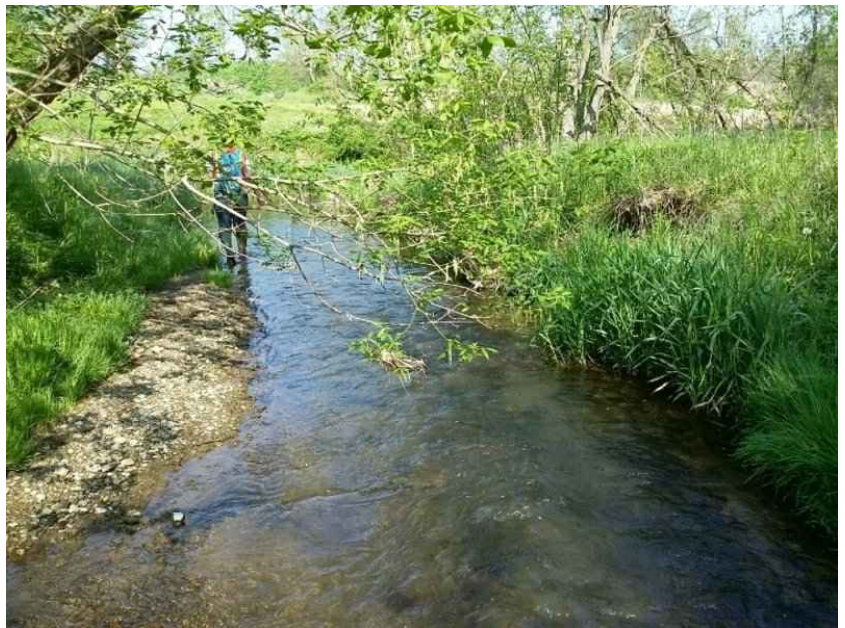
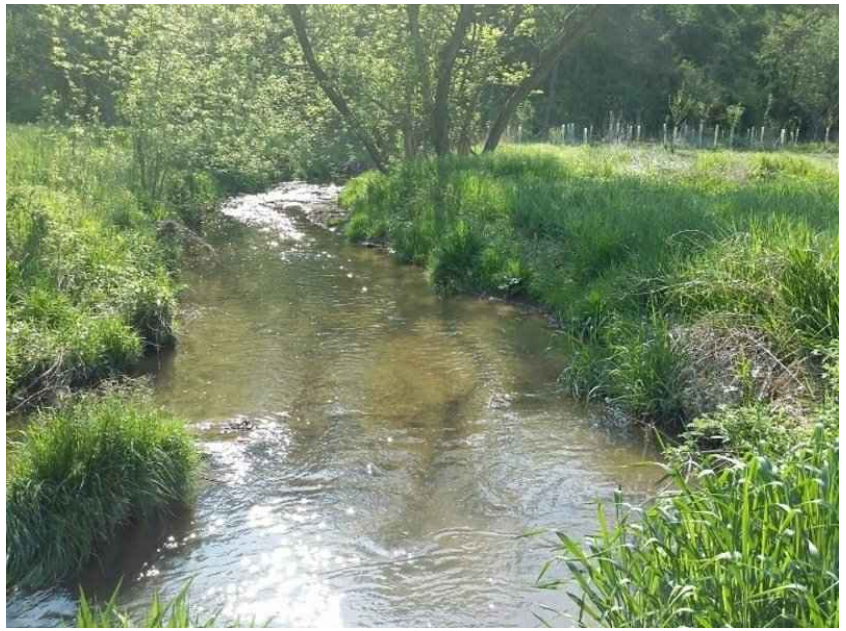
Photos

| Reach Setting | Bounded by restored section on upstream end, property fence on downstream end. Un-restored area is destined for restoration by Chesapeake Conservation within the next few years if permitting/funding comes through. |

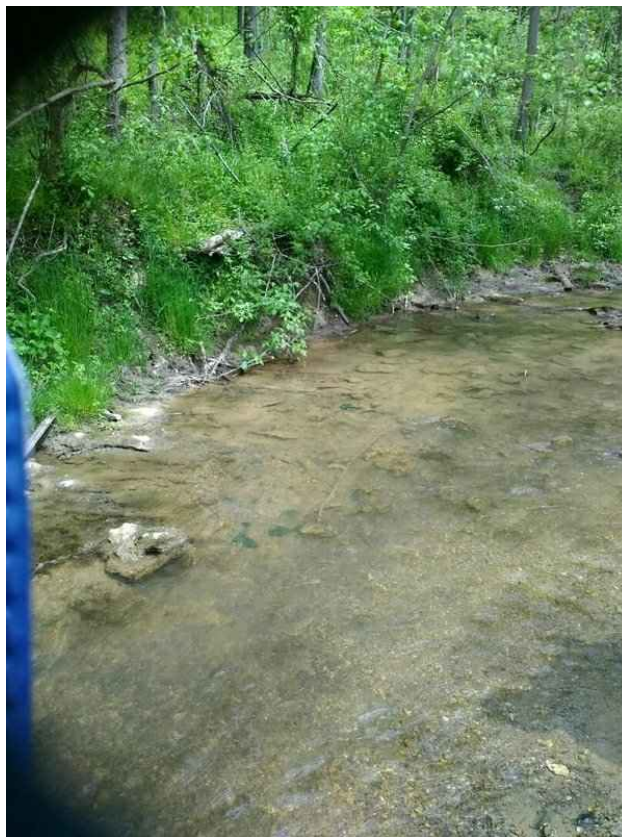
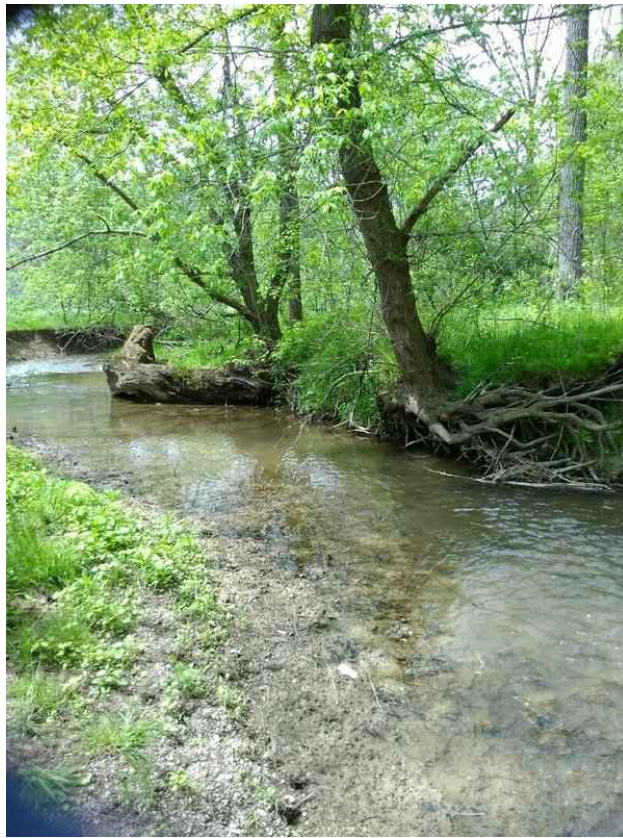
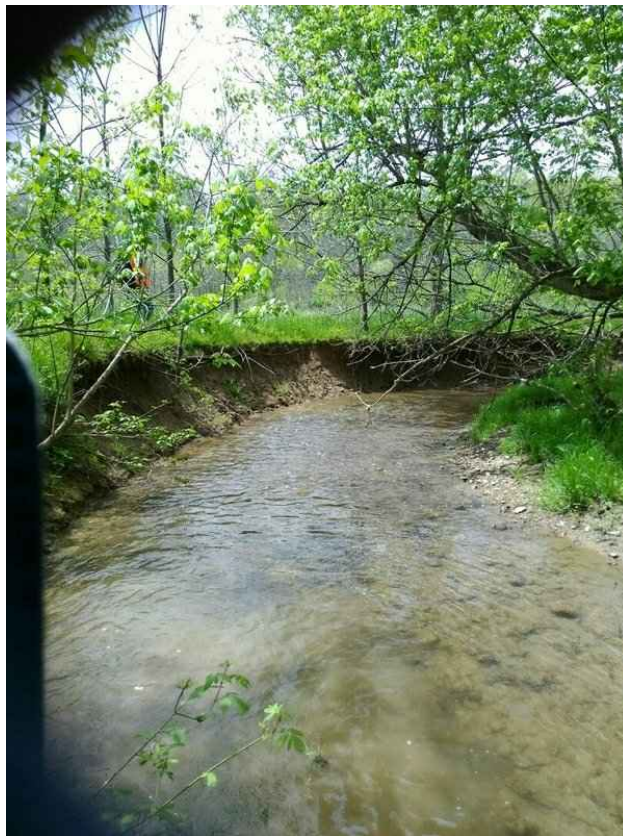
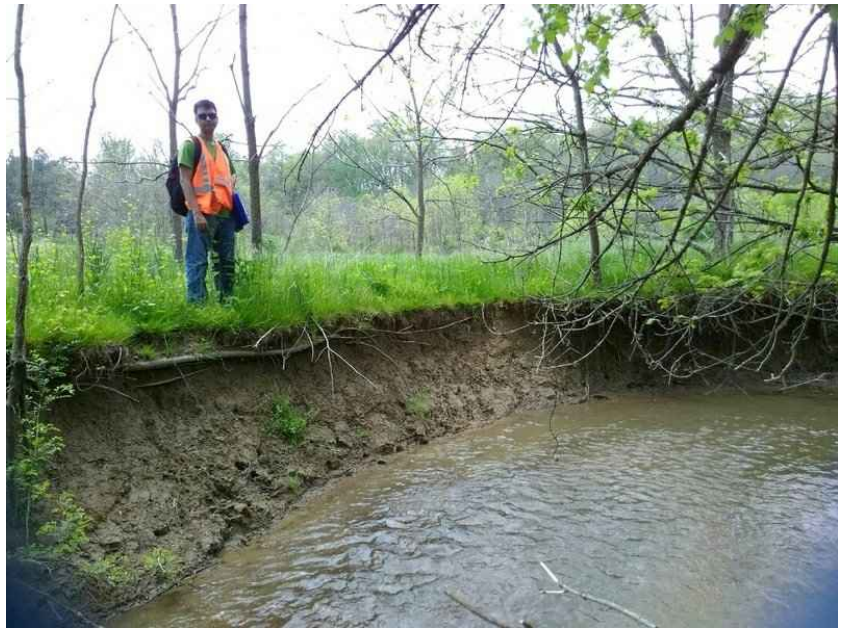
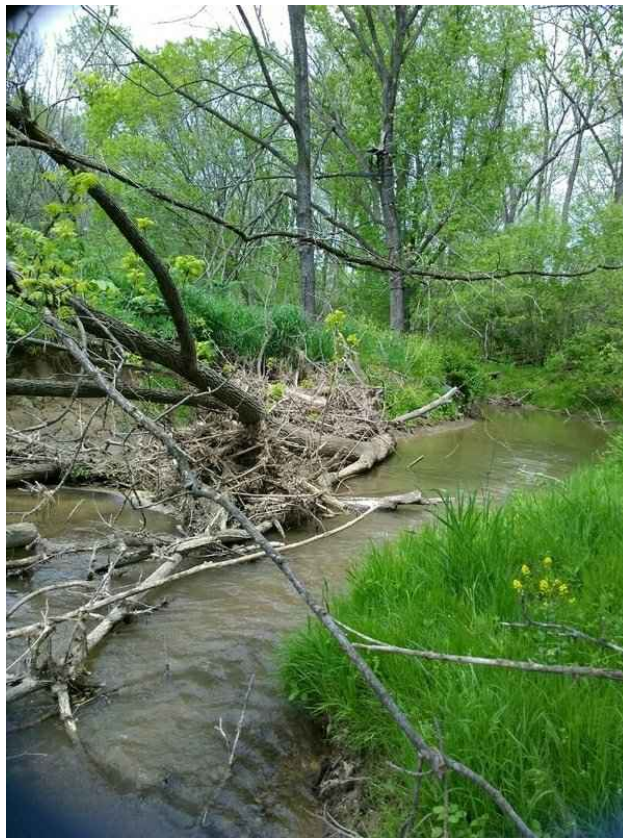
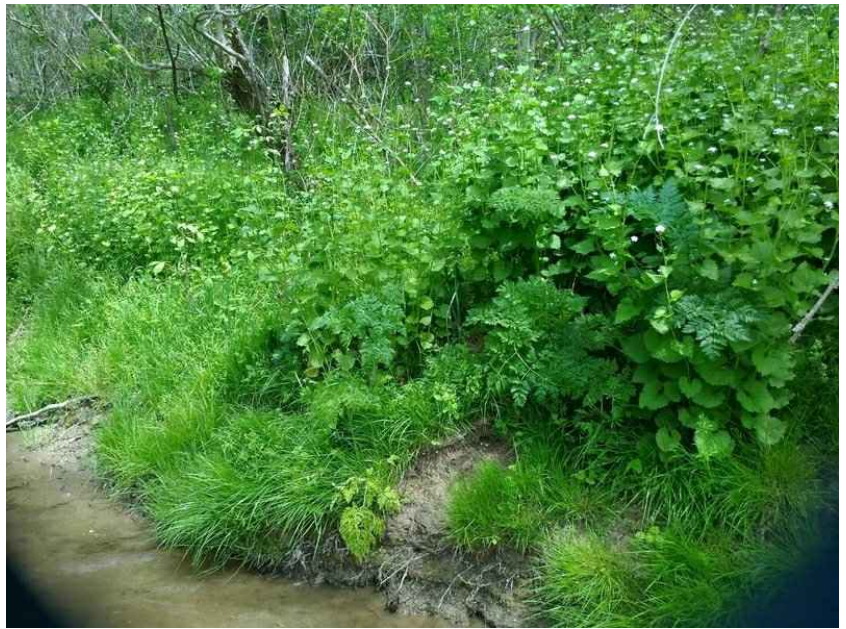
Photos

| Reach Setting | Beaver Dam Road bounds stream reach on both ends. Site is a farm, used for cattle pasture. Constrained by electric fence around concrete cattle stream crossing mid-reach. |

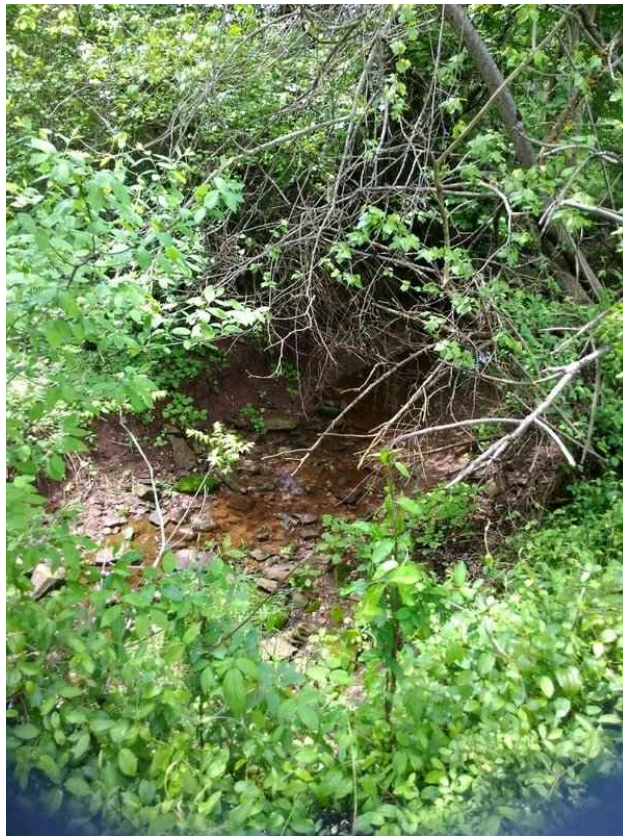
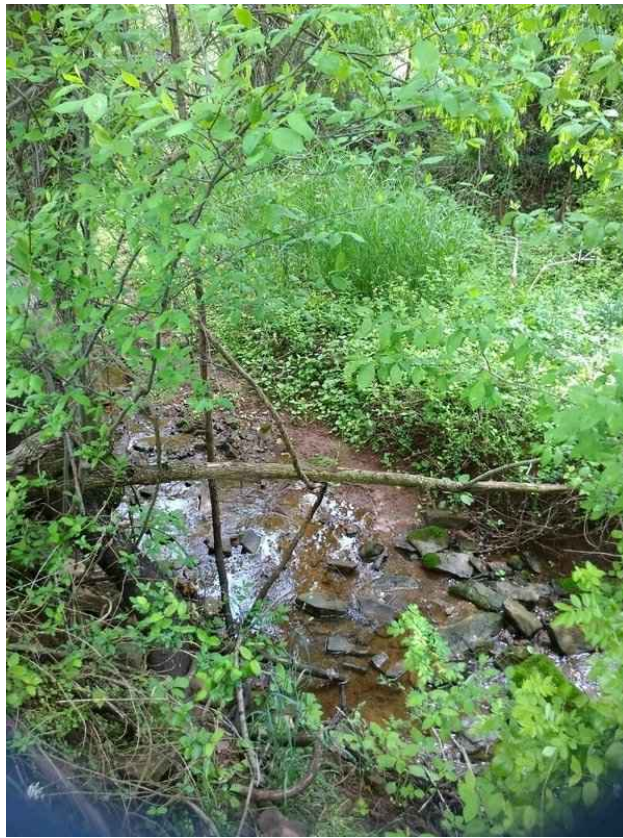
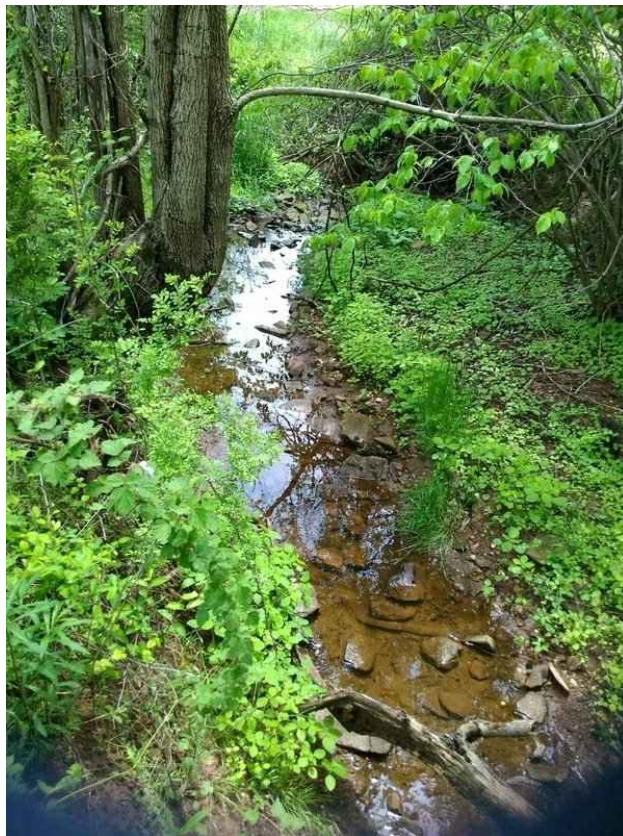
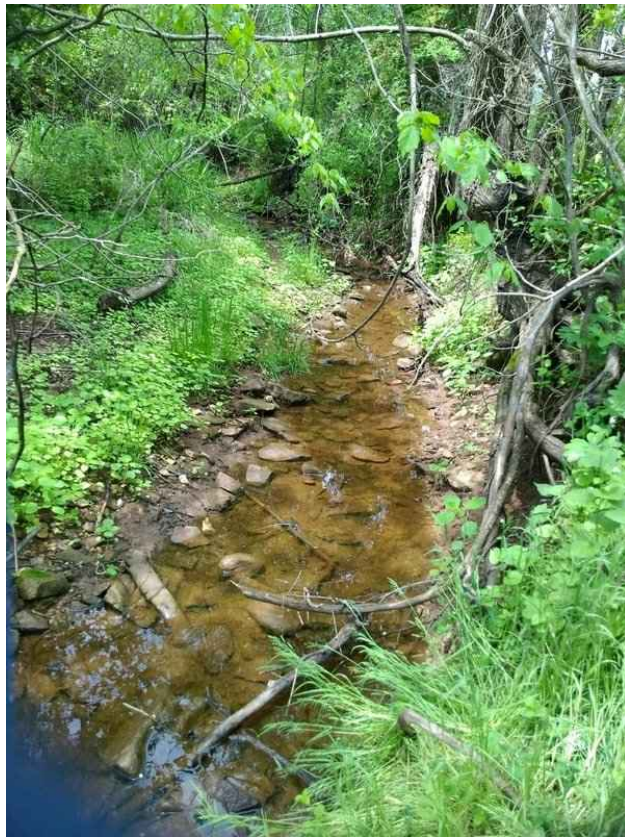
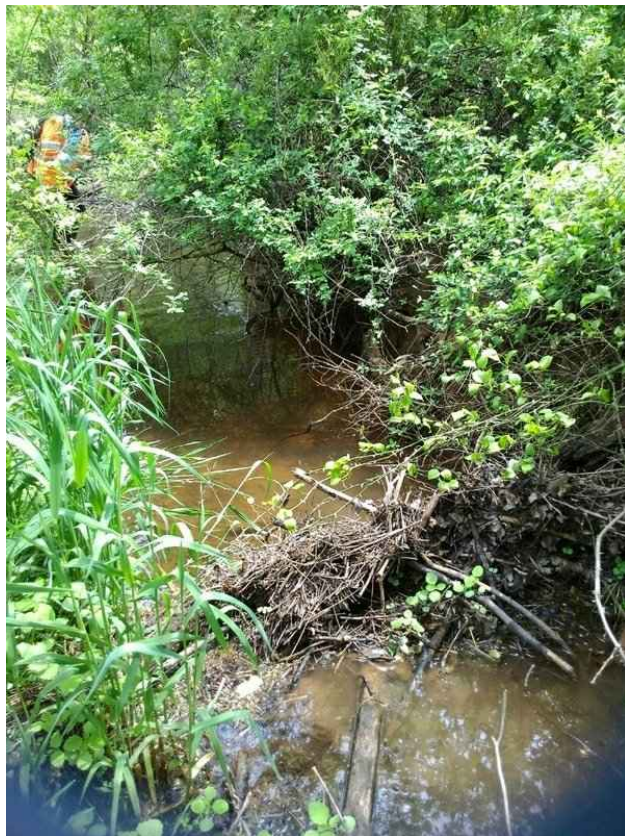
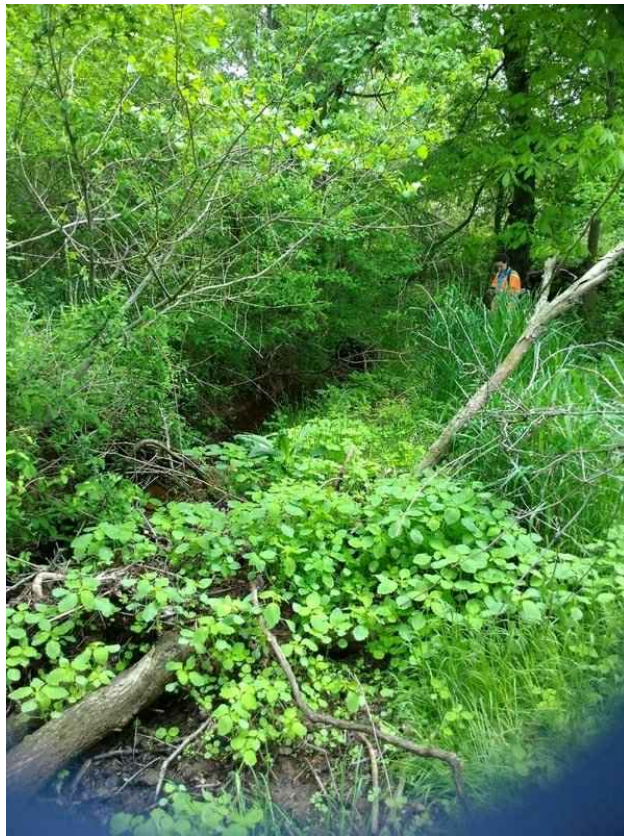
Photos

| Reach Setting | U/s property boundary. Downstream, culvert at Bunker Hill Rd. Predominantly wooded area except D/S right side and u/s left side |

| Lateral Adjustments Notes | Bank erosion on outer bends in meandering sections. Up to 5 feet high. Undercut trees observed throughout. a few small side bars |
| Bank Erosion | Headlights, piping points throughout. Rotational failure noted on outer bends in meandering sections |

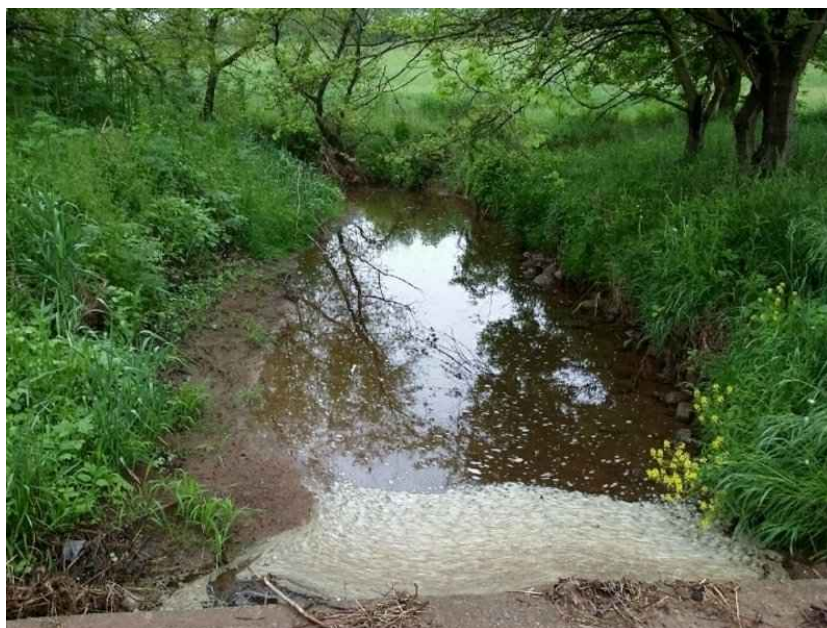
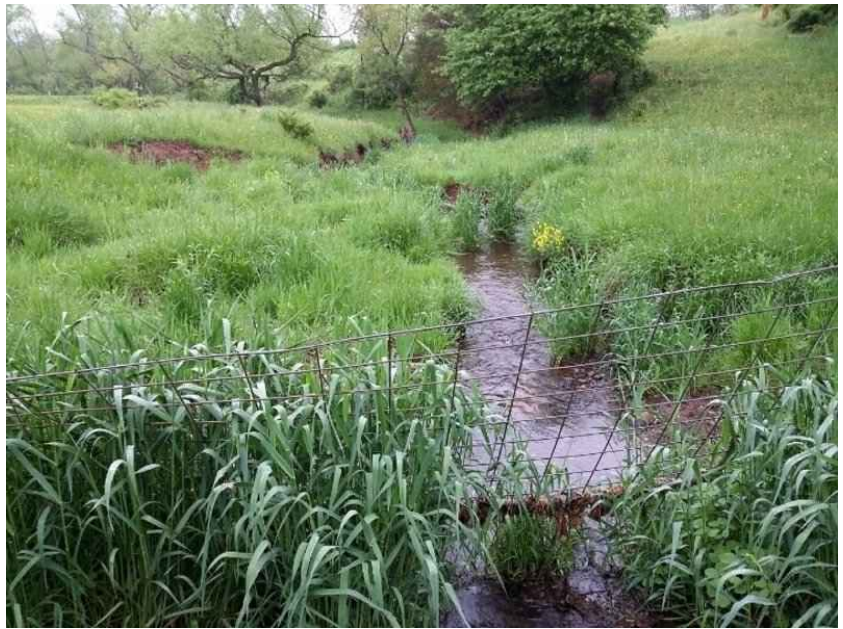
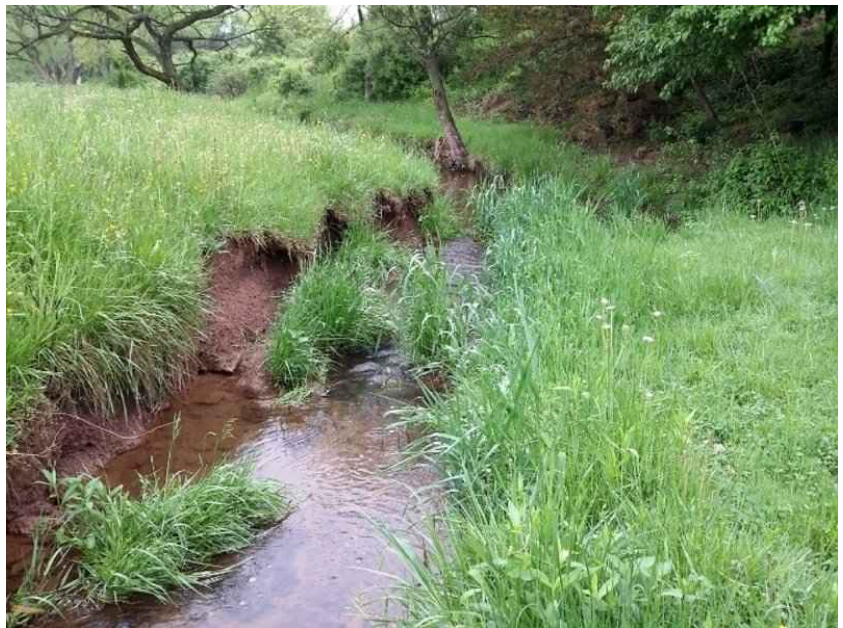
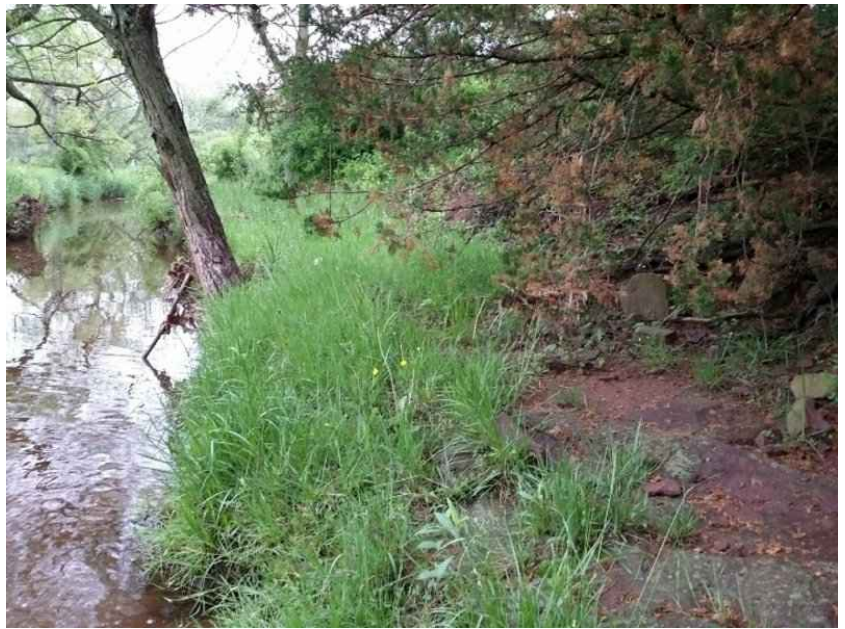
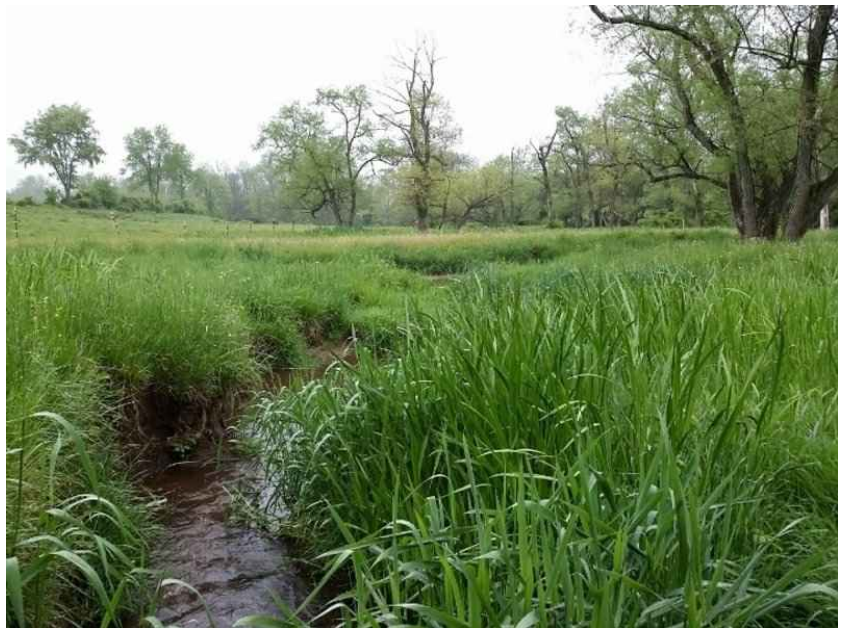
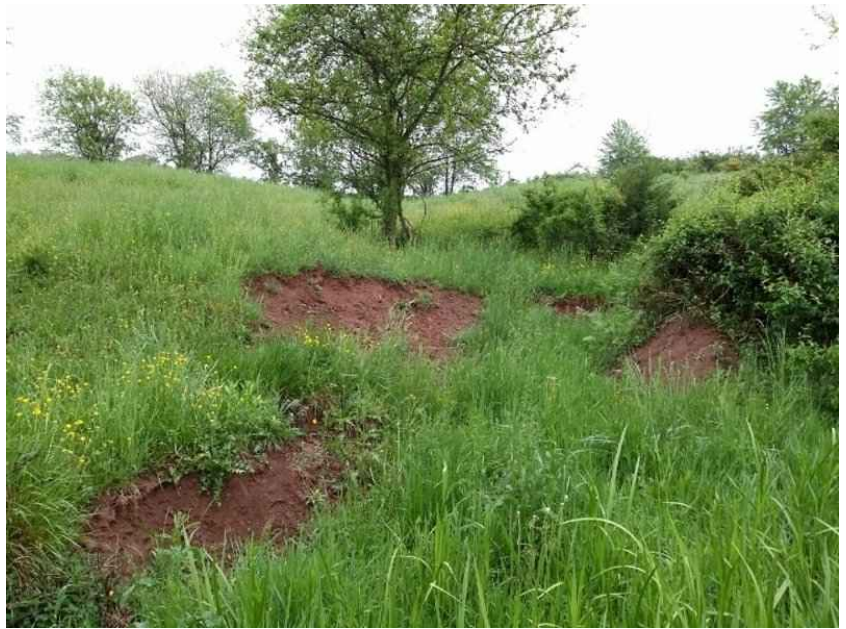
Photos

Reach Setting

U/s wooded edge of field. Low point of valley. L- meadow field. R- active ag use, livestock present.

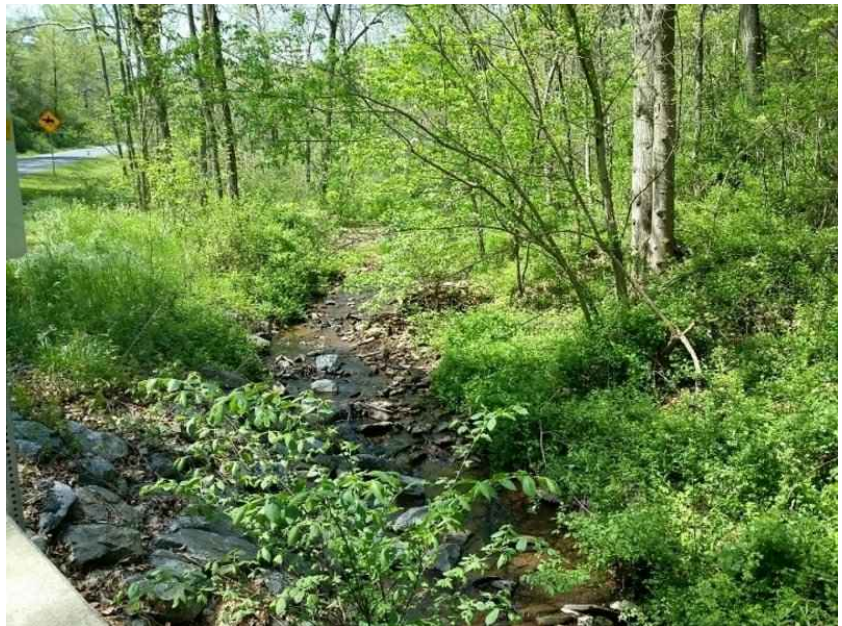
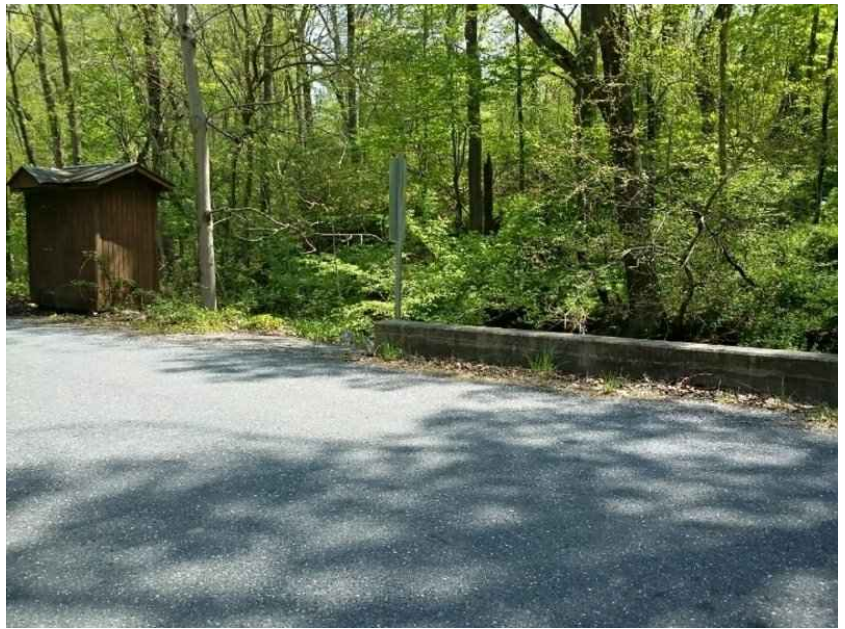
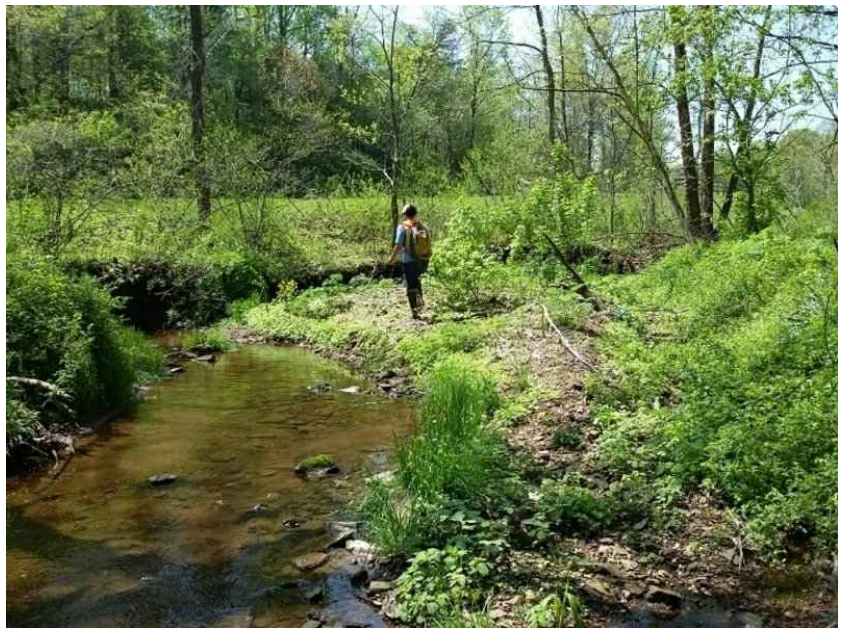
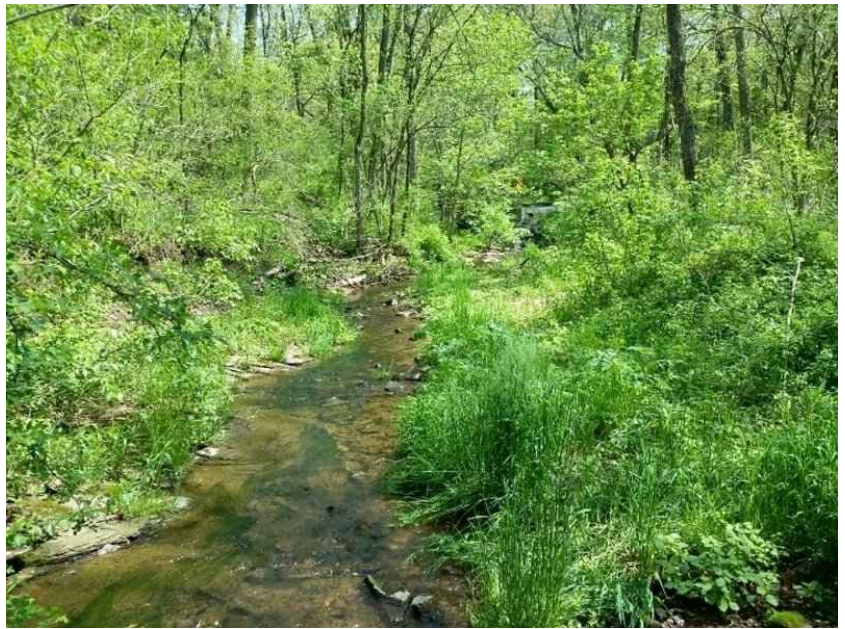
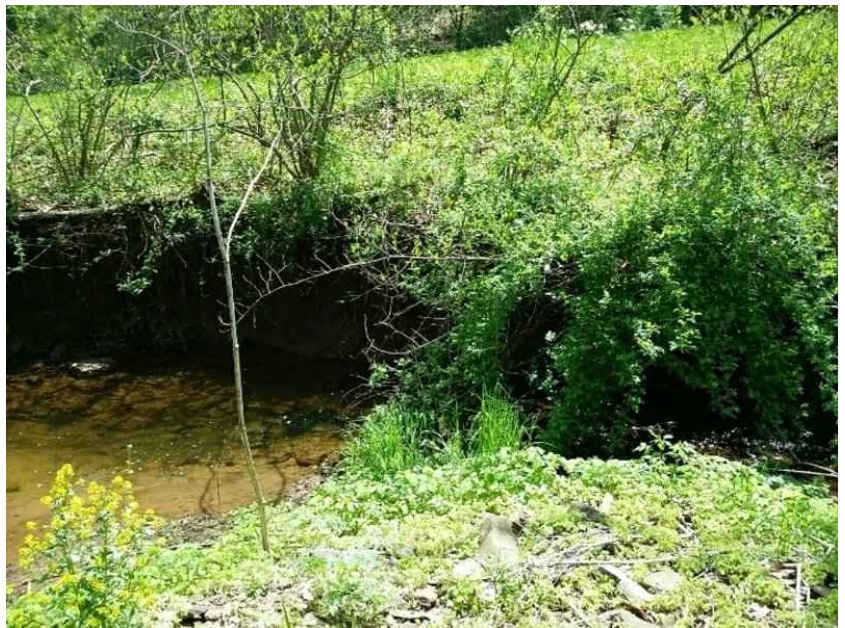
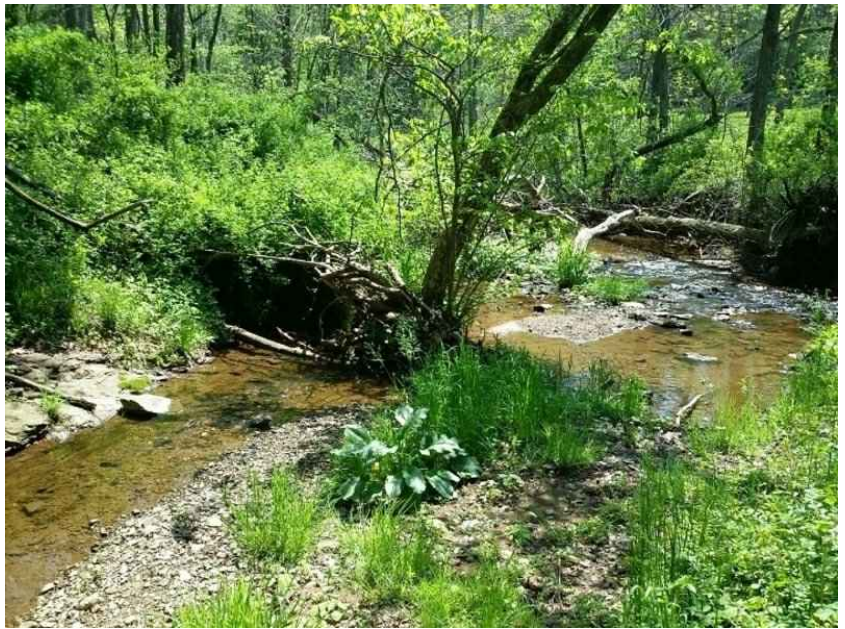
Photos

| Reach Setting | Upstream boundary is fence on property line, downstream is the keymar rd bridge. Horse farm pasture along much of right side of stream, buffered by short valley slope. Left side is valley slope as well |
| Dominant Bed Material | Sand, Gravel |

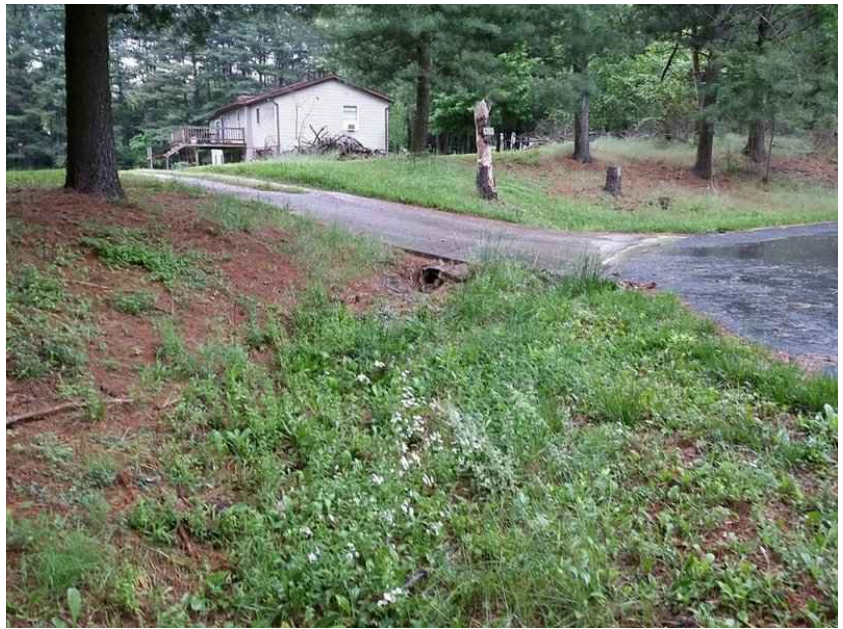
Property to the right of the ex. carpet and rip rap flow path

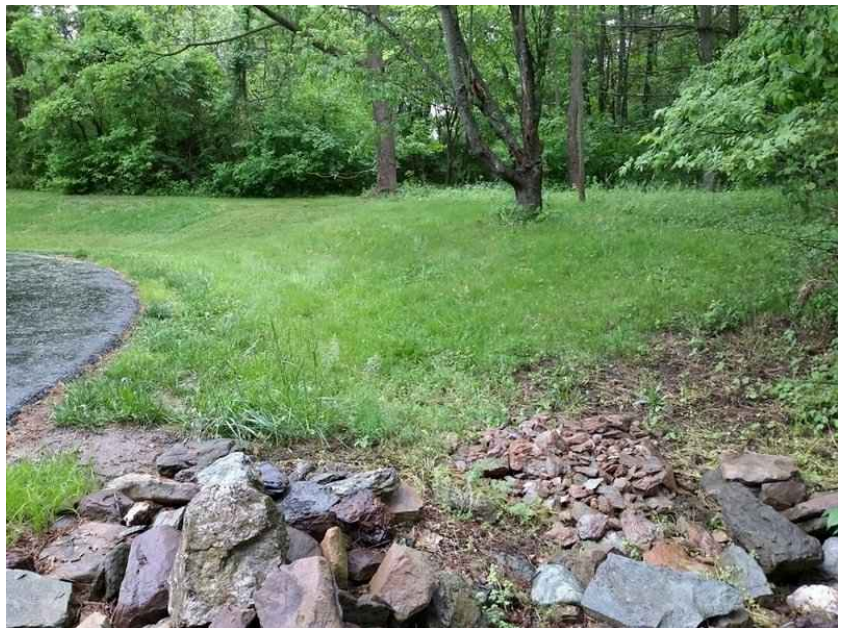
To the left of the ex. carpet and rip rap flow path

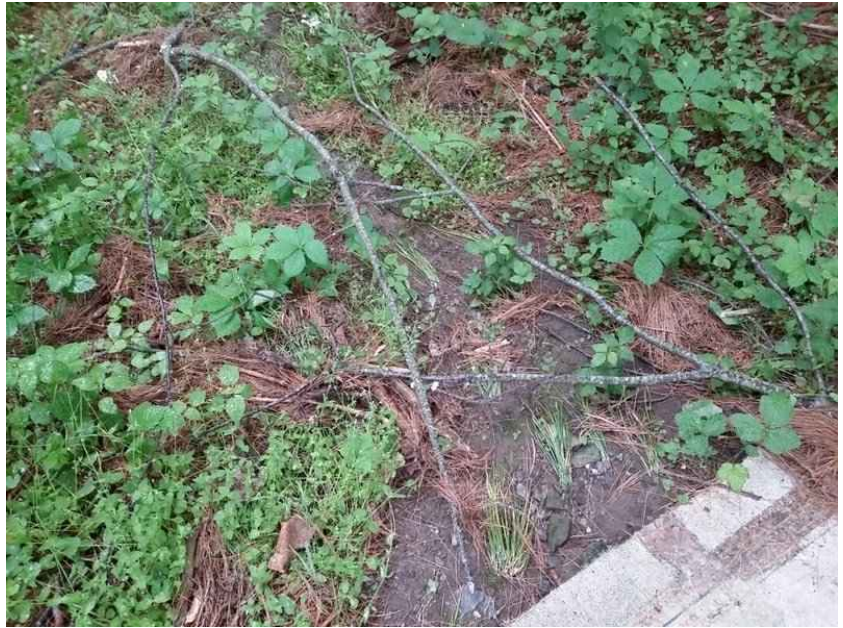
Minor erosion downstream of carpeted area.

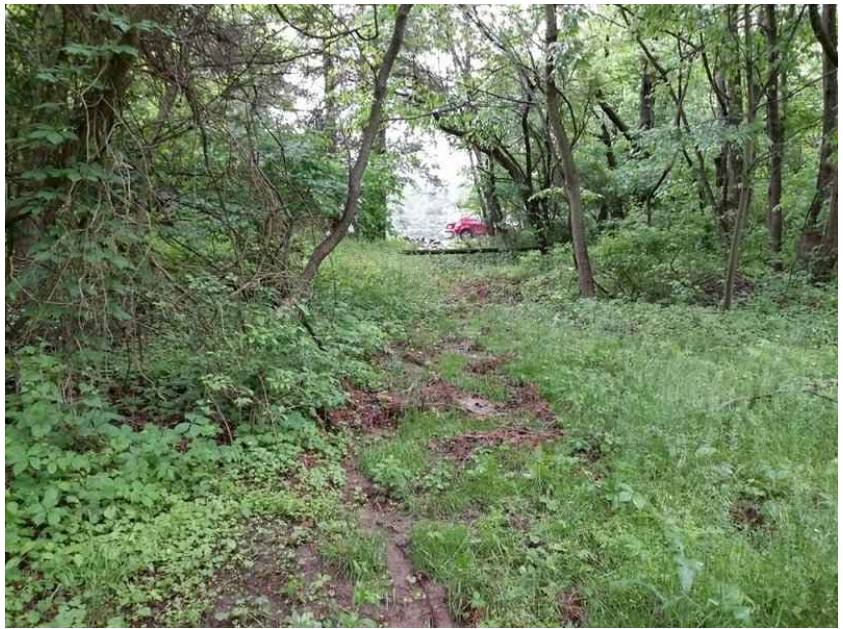
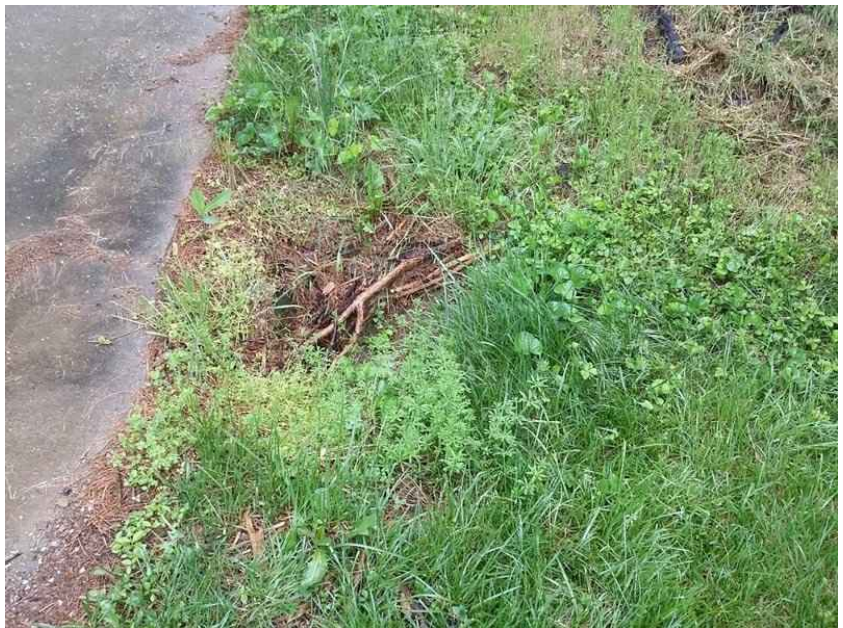
Inlet to culvert under driveway on parcel.

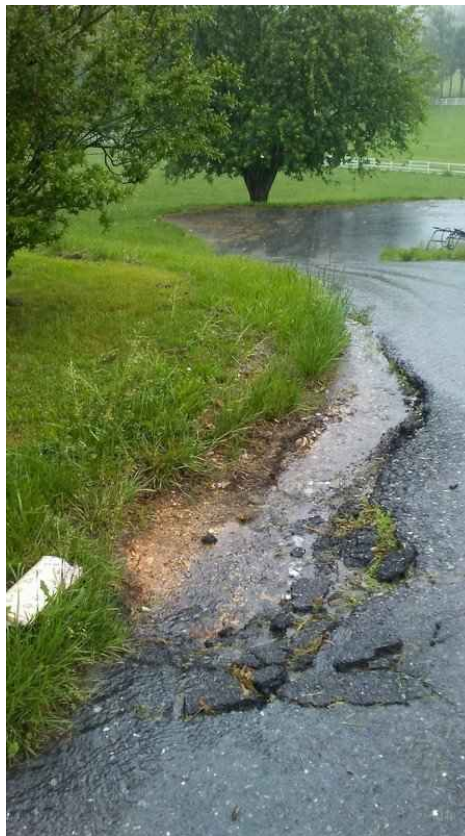
Concentrated flow path - stormwater thalweg

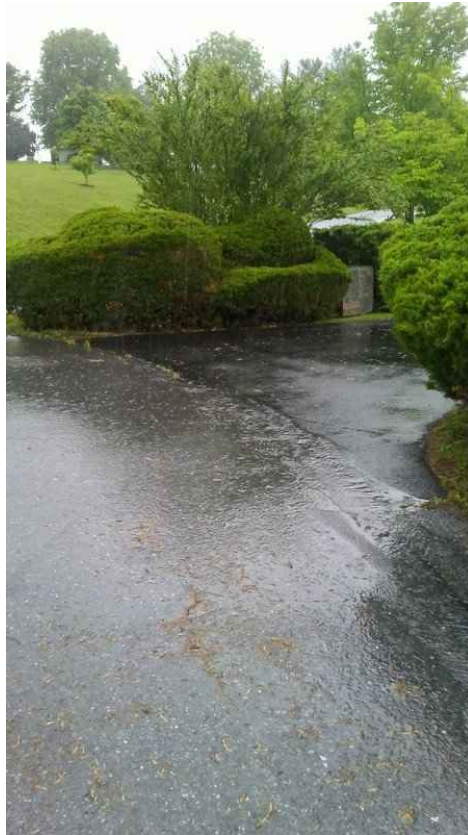
Concentrated stormwater flow path upstream of previous image

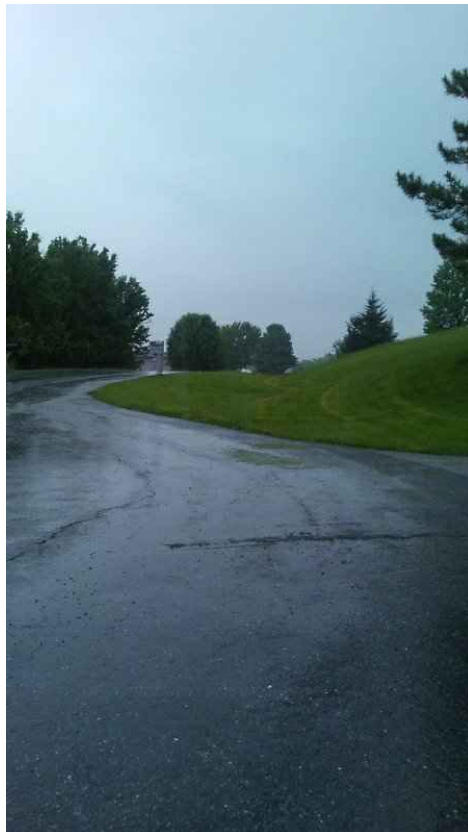
Development drainage swale. No culverts.

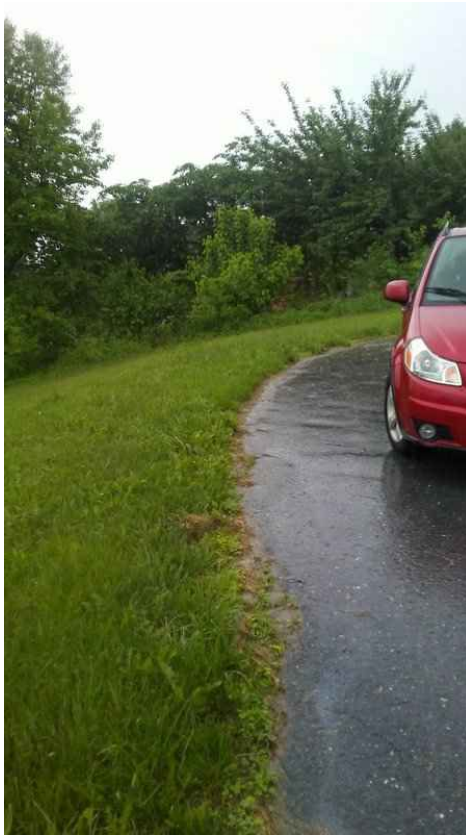
Concentrated flow on the right side of parcel driveway.

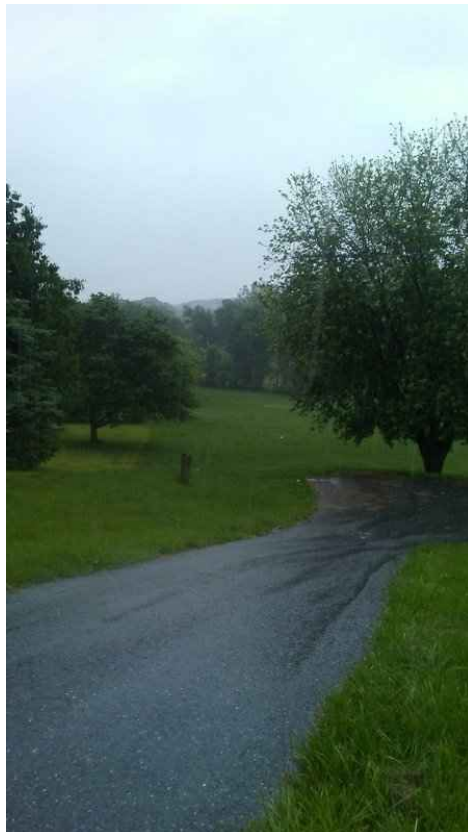
Field where sand filter could be located. White dot is septic system access.

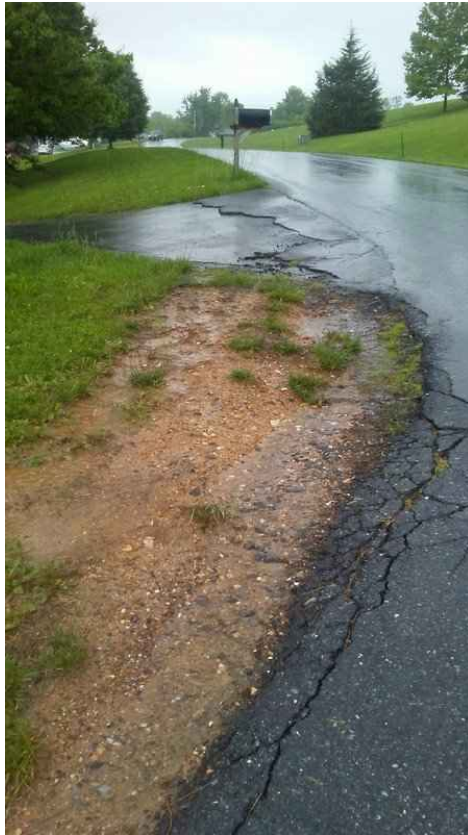
Erosion upstream of driveway, on right side (when looking downstream)

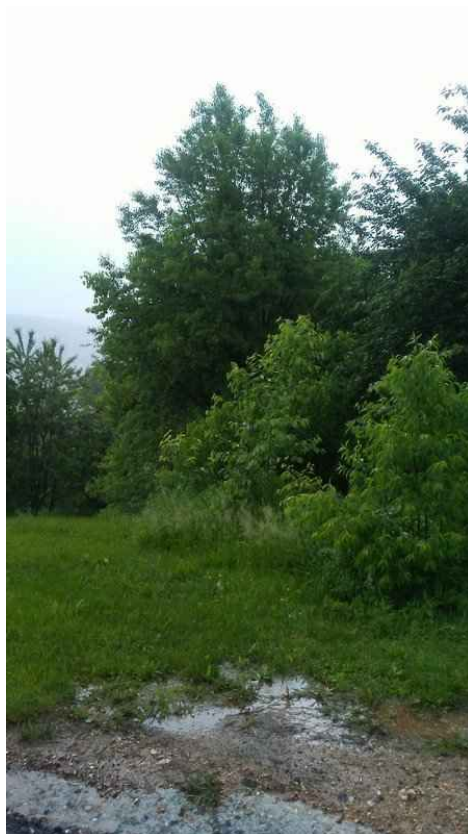
Property line, area for potential grass swale/RSC. Erosion on right side of driveway.

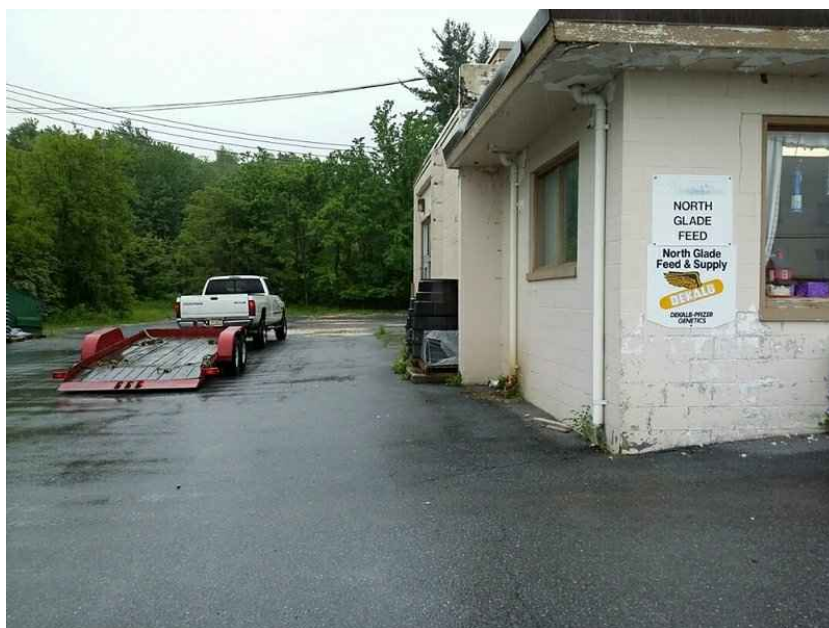
Roof drains run over parking lot into ex. grass swale

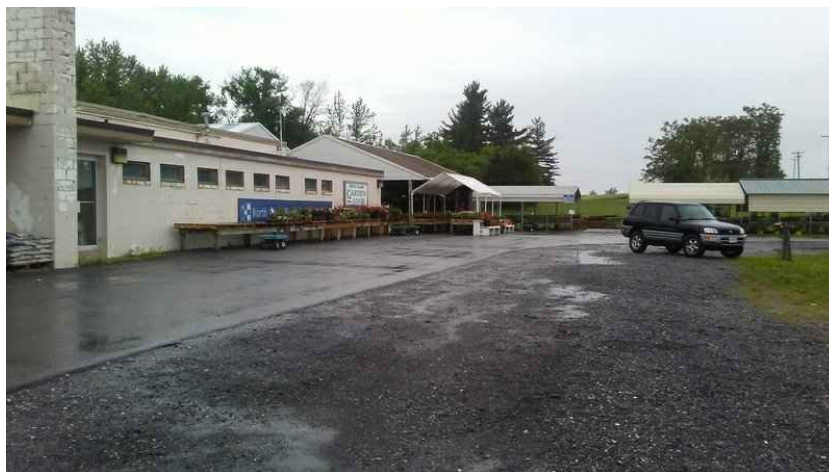
Some of parking area is gravel. Some ponding especially near edge of asphalt area.

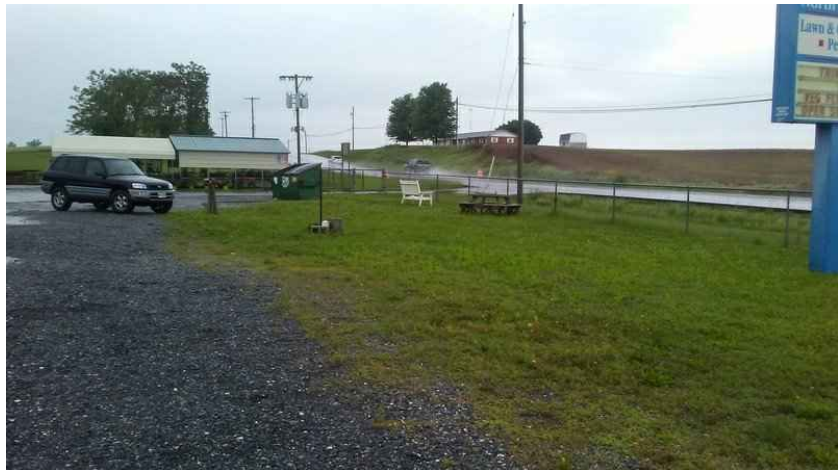
Grass swale in front of property. Drains into ex. grass swale on side of property (then into stream).

| BMP Setting | Grassed swale with some gravels at the bottome. Stable condition |
